HUNTSVILLE DAM

NDS ID NO. PA-00553

PHASE I INSPECTION REPORT
NATIONAL DAM INSPECTION PROGRAM

JUNE 1978

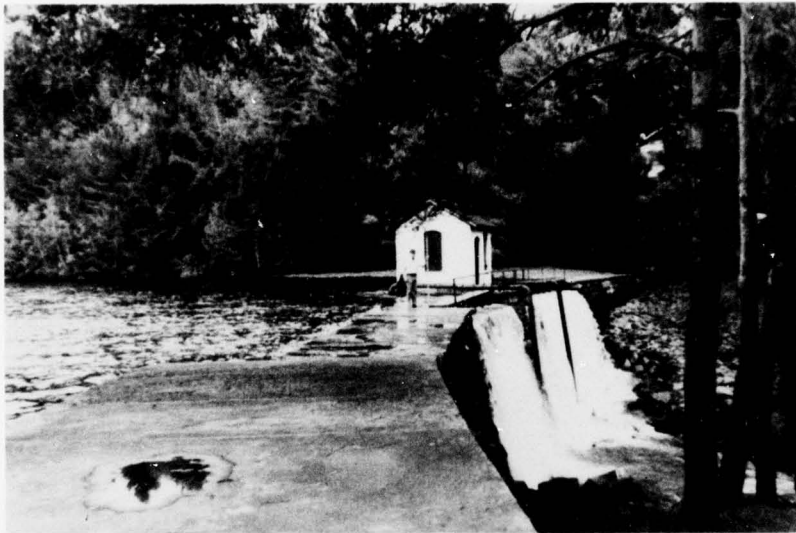
(1) It was noted that the operating floor of the gatehouse is situated at the same elevation as the crest of the auxiliary spillway (Photographs A and B). Consequently, if the reservoir level were at top of dam, the operating floor would be submerged to a depth of 2 feet.

A. Top of Dam and Auxiliary and Main Spillways. Access to Gatehouse is Plank Footbridge Over Main Spillway.

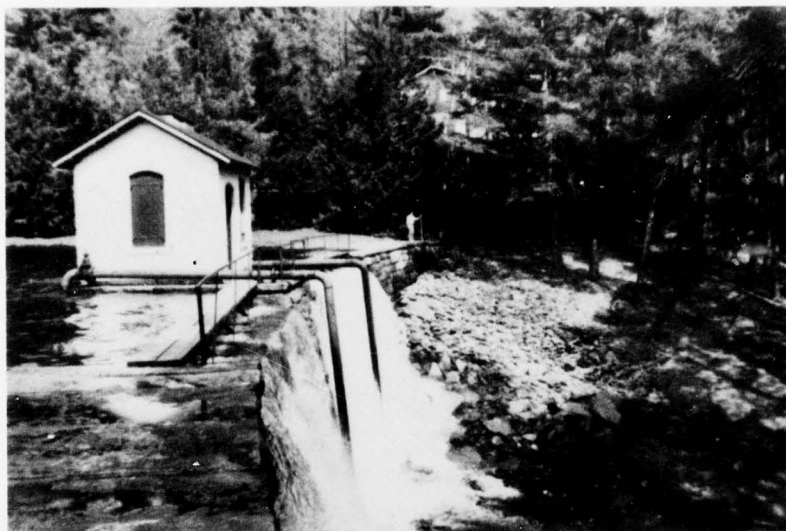
C. Downstream Face of Dam,
Left Abutment and Riprap at
Downstream Toe of Left Auxiliary Spillway.

(4) Repair area at toe of left auxiliary spillway where riprap is displaced. Some larger stone should be provided.

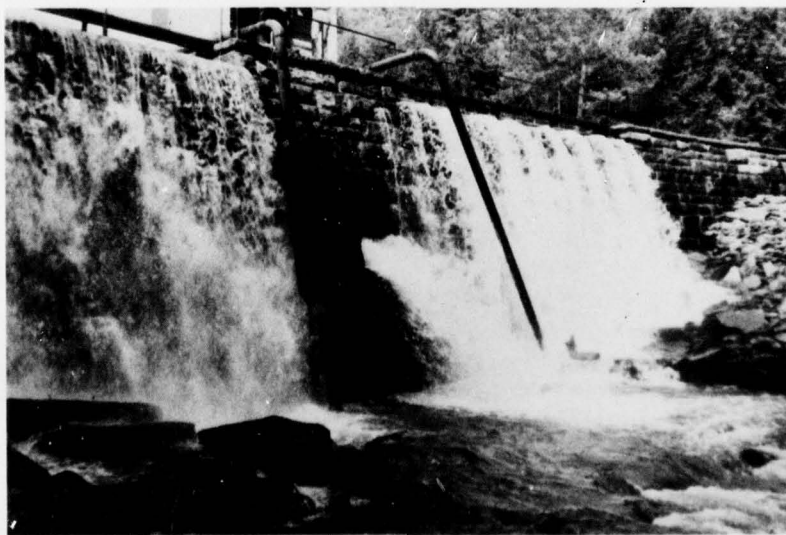
D. Upper Outlet Conduit During Operation.
Leakage from Dam Visible Above Conduit.

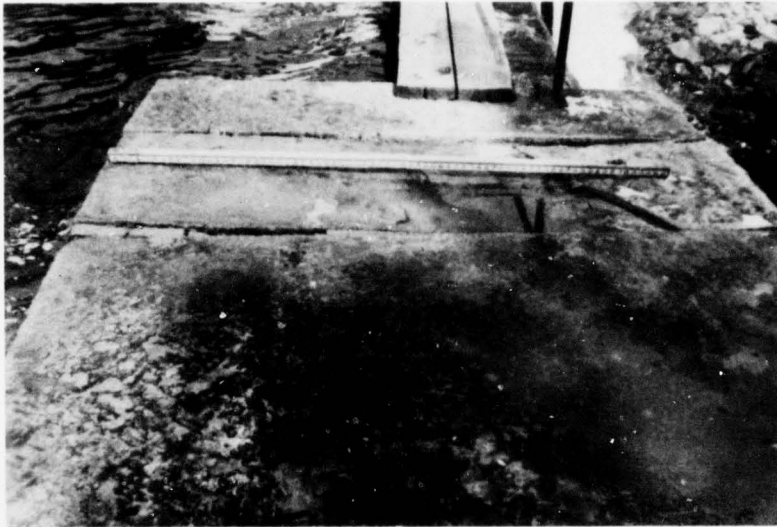
(4) Vertical variations of +2 inches were noted for the capstones across the lengths of the various sections. One capstone on the crest of the right auxiliary spillway section was broken (Photograph E). It was also observed that the capstones on the crest of the right auxiliary spillway overhung the downstream face by a larger amount than those on the left auxiliary spillway. The caretaker said that the stones have been displaced laterally by ice forces. Mortar was missing from some of the joints between the capstones. Views of the top of the structure are shown on Photographs A, B, C, and E.

(3) The vertical irregularities of the capstones on the structure have little consequence. The lateral displacement apparently caused by ice forces indicates that the stones are not properly secured to the underlying structure. These capstones are primarily for appearance sake, and even if they were completely displaced it is doubtful that the underlying structure would be affected.

E. Broken Capstone and Missing Mortar
at End of Right Auxiliary Spillway

(2) Make repairs to capstones on crest of structure.

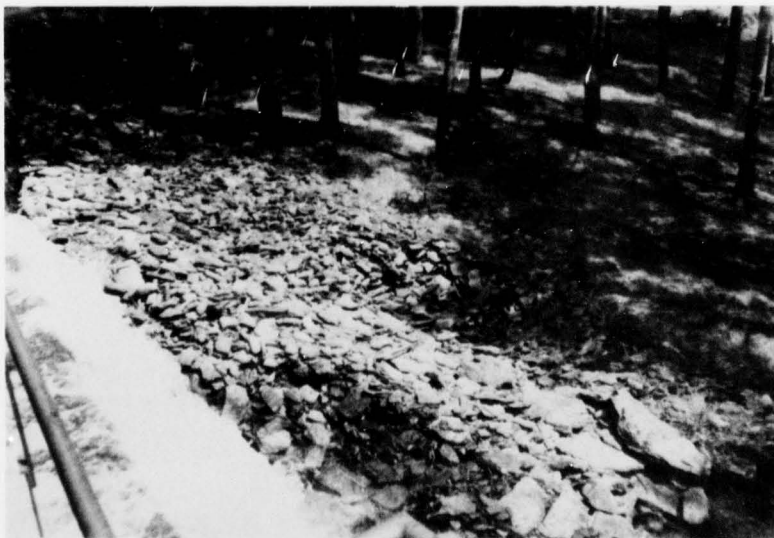
F. Sandstone Riprap Below Left Auxiliary Spillway

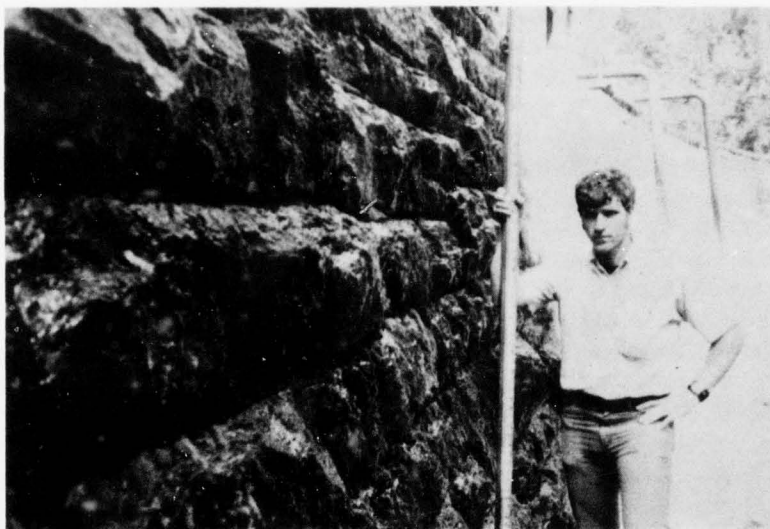
(2) The mortar in the joints on the downstream face of the structure was generally cracked and loose or missing altogether (Photograph G). Seepage was observed over most of the downstream face, and it ranged from drips to concentrated flows of up to 5 gpm. The largest single leak was located near the top of the raised center section between the two sections of the main spillway (Photograph D). This leak was estimated to be about 25 gpm. It should be noted that too much flow was going over the main spillway sections to determine the condition of the downstream face in those reaches. The amount of flow also made it impossible to inspect the toe of the main spillway for undermining. The leakage from the downstream face entered either the natural stream channel or the slope protection adjacent to it. No apparent damage to other features has resulted from the seepage. The caretaker said that the dam was routed and the joints on the downstream face were repointed in 1962. He said that the leakage at that time was considerably greater than that observed during this inspection and that the repair work stopped almost all of the leakage.

(1) The condition of the mortar in the joints on the downstream face of the structure and the leakage therefrom did not appear to have progressed to the extent that the integrity of the structure is in question. However, the condition is undesirable and will worsen in time.

G. Loose and Missing Mortar at Masonry Joints
on Downstream Face of Right Auxiliary Spillway

(1) Monitor condition of mortar in joints and amount of seepage from downstream face and make repairs when necessary.

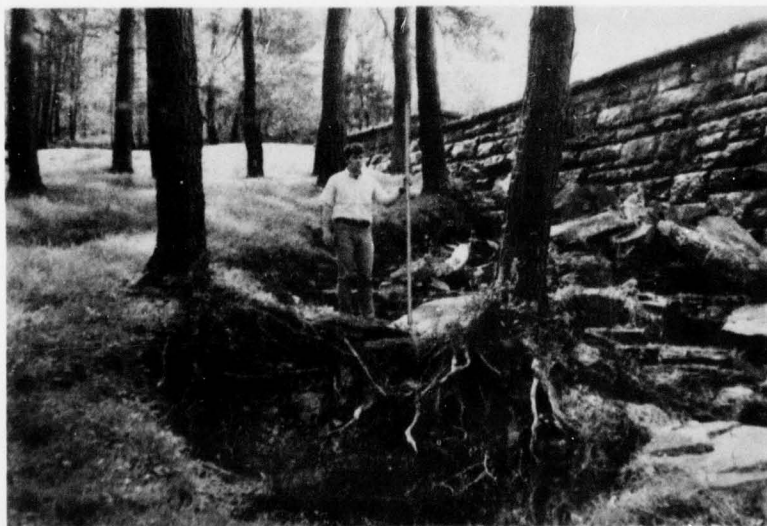
H. Eroded Area Downstream from
Right Auxiliary Spillway

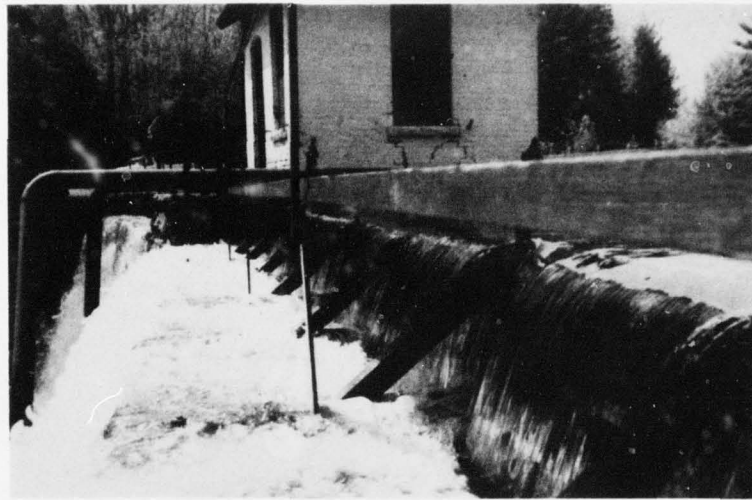
(6) The effect of the flashboards on the main spillway crest is reduced spillway capacity. Flashboards are normally designed to fail when the pool rises to a certain level above the top of the flashboards. It is also normal operating procedure to remove the flashboards during the winter and spring months when the threat of a flood is generally the greatest.

I. Flashboards on Main Spillway

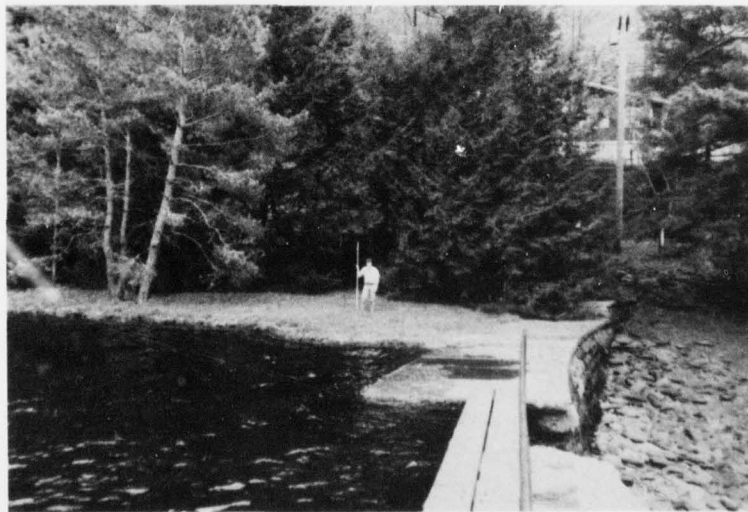
J. Left Auxiliary Spillway Approach Area
